SAFETY WARNING

LAPPAS has received a limited number of notifications concerning “Heat-Affected Zone (HAZ)” – white signs in Rings with Welded joints.

The reports of failure have been limited to few Rings from batch August 2021-December 2022

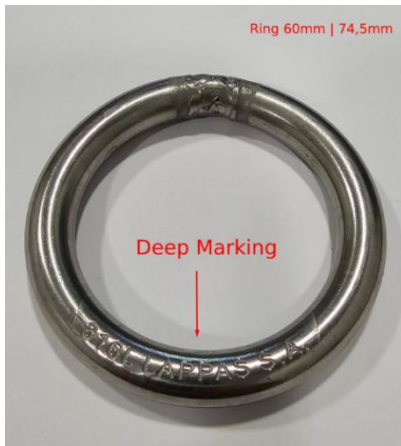
Photo 1

The ring in this photo (1) is from the batch August 2021-December 2022.
Pay attention to the details written with red color:

- Deep Marking: “316L LAPPAS S.A.”
- ✓ Only a limited number of Rings from this batch has been reported with failure.

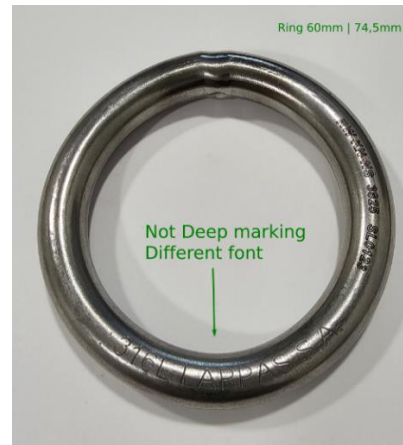
Photo 2

The ring in this photo (2) is from another batch (2023) with a different welding process.
Pay attention to the details written with red color:

- Not Deep Marking: “316L LAPPAS S.A.”
- Different font

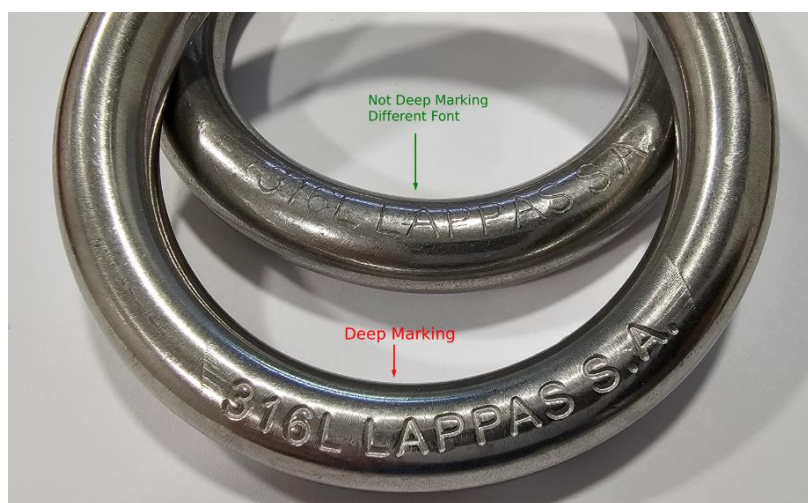
Photo 3

In this photo (3) you can see the two rings together and detect each one easily.

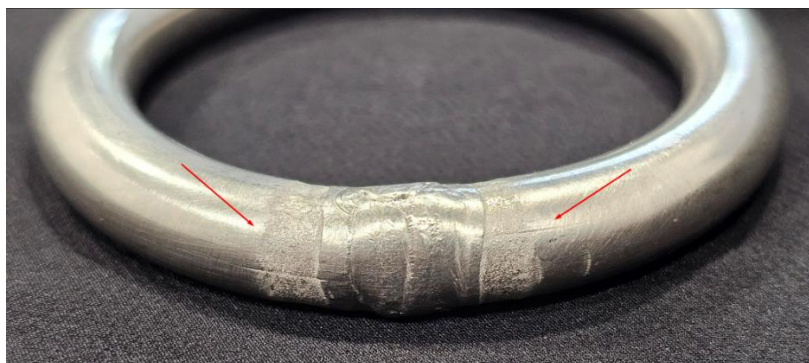
Photo 4

This photo (4) will help you recognize the Rings that have been reported with failure at the Welded joints: "Heat-Affected Zone (HAZ)" - white signs on the left and the right of the Welded joints.

All units from the specific batch must be inspected and returned in case of “Heat-Affected Zone (HAZ)” – white signs.

1. Inform us with the results of the inspection
2. Contact us via the email: info@lappasclimbing.com

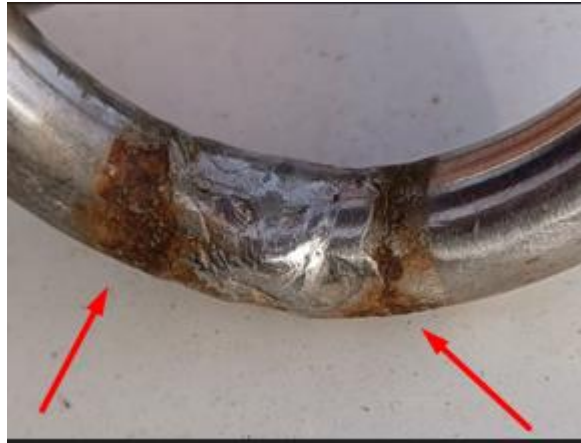
Photo 5

In this photo (5) you can easily recognize the “Heat-Affected Zone (HAZ)” signs on the left and right of the Welded joints after being set-in place for a few months/years and under low loads.
