Sharp edges and rope cuts

This document is an English language translation of the original 'Skarpe kanter og taukutt', produced in Norwegian by the Norges klatreforbund (NKF)/Norwegian Climbing Federation (NCF), a UIAA full member. The document is produced in collaboration between the safety commissions of the NKF/NCF and the UIAA.

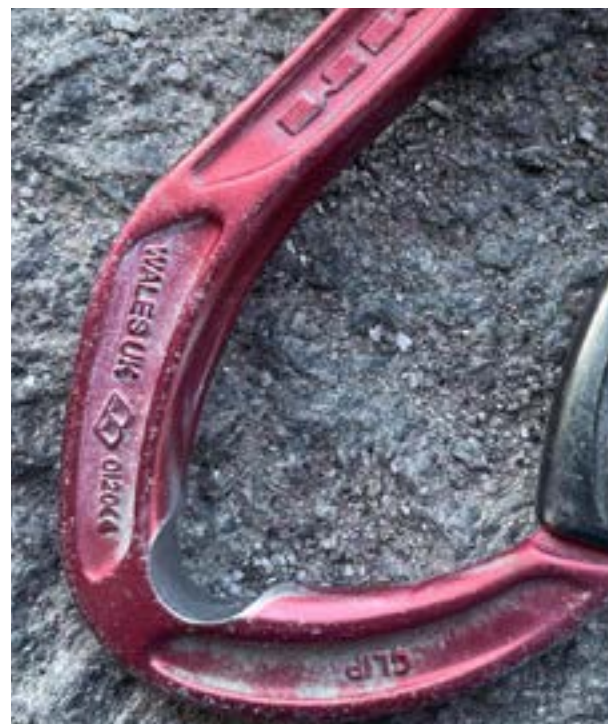
Shear forces commonly occur in the belay system, but they become very dangerous if there are sharp edges on the metal that the rope slides over. Especially carabiners that have been in place on a route for a long time will wear from repeated lower-offs. Deep grooves can form in the carabiner material, and sharp edges can be found in these grooves. Such grooves often form in carabiners on the first and second bolt on the route, or under overhangs where the rope changes direction. Such edges do not necessarily feel sharp when touched with a finger, but they could be more than sharp enough to damage a rope that is forcefully loaded over the edge. In the worst case, it is cut completely. The carabiner pictured below belonged to a permanently placed sling that was taken down from the route Aloha on the crag *Beachen* in 2022. The risk of rope damage or rope cuts on this carabiner is very real.

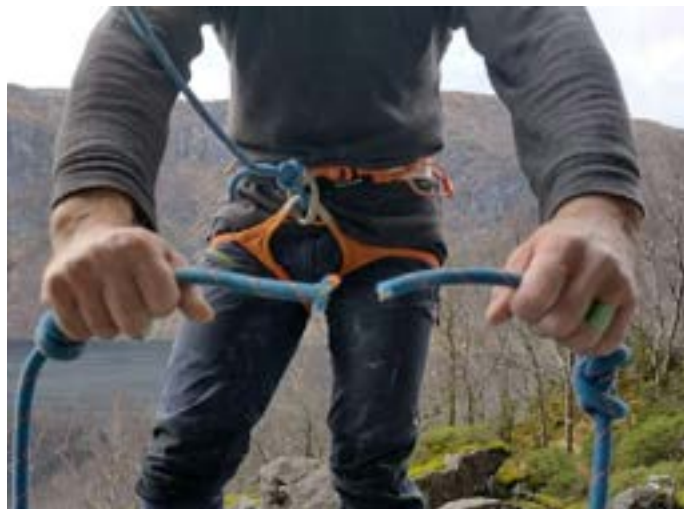
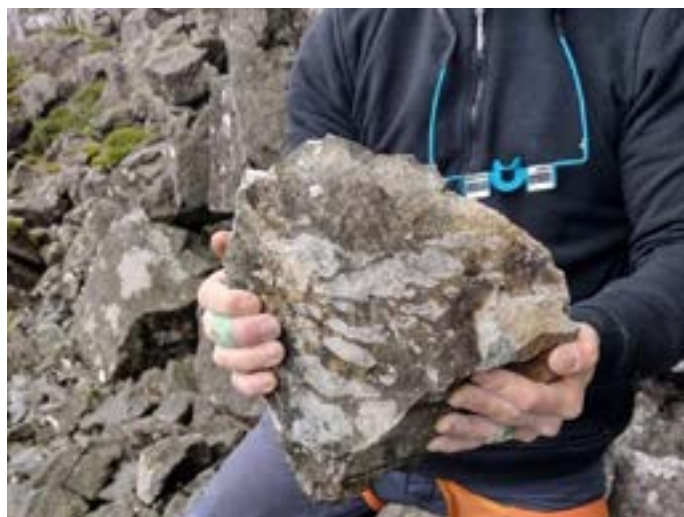
Rope cut by falling rocks at the Hetta climbing crag in Vaksdal. The picture above shows the cut rope. The picture below shows the rock that came loose when the climber stepped on it.

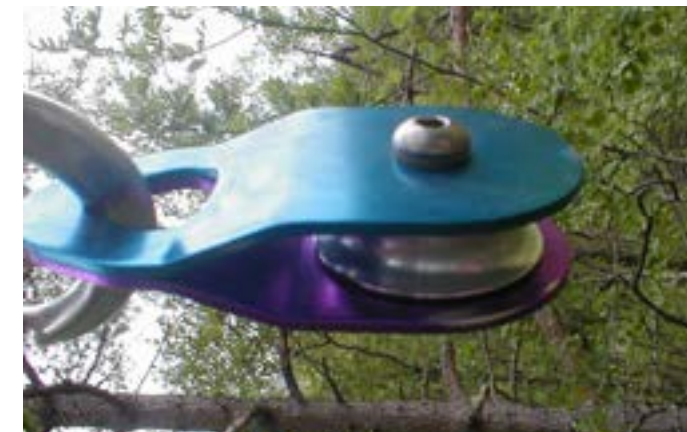
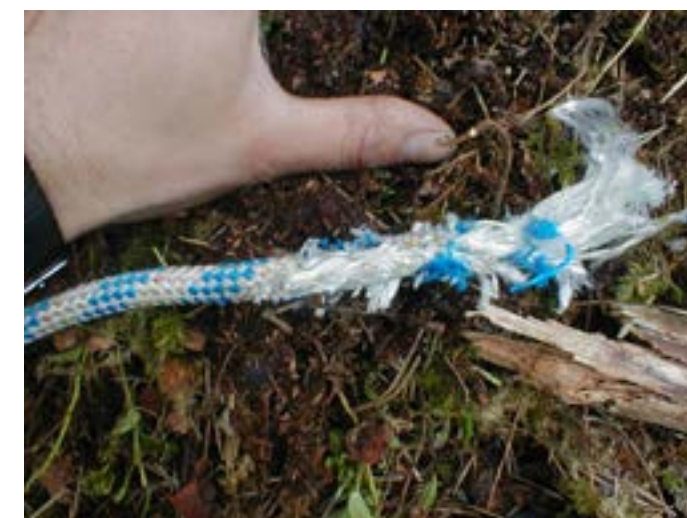
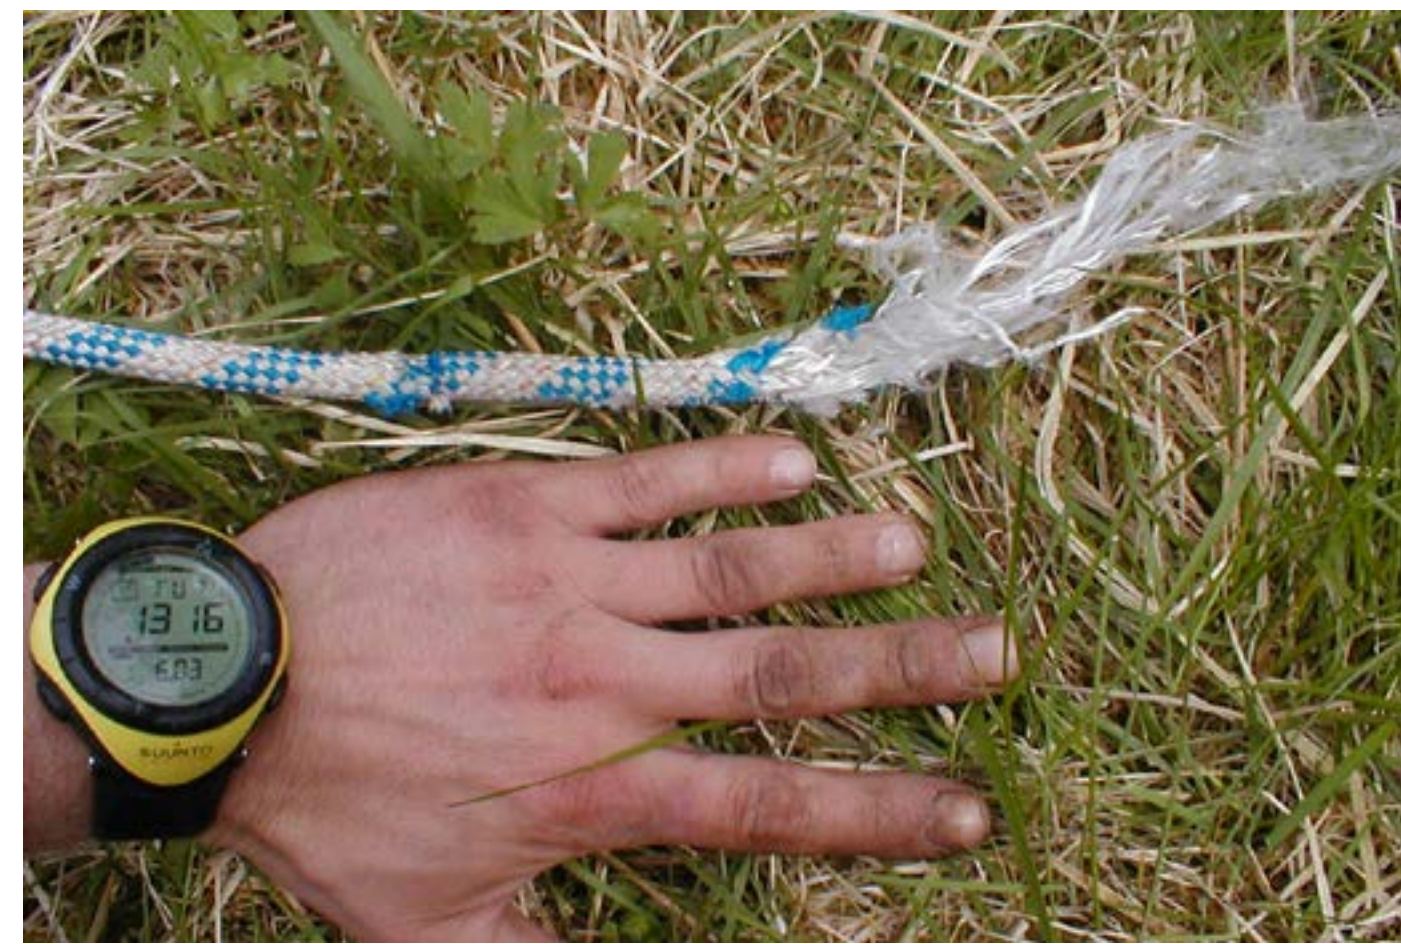
June 2003, Sunnmøre

A low stretch rope rigged for a Tyrolean traverse broke when a teenage student reached the end of the traverse. When the braking rope was about to stop the final movement, the rope of the Tyrolean bounced a little up and down and broke at the top anchor. The anchor at the top was rigged at an angle so that the rope was not allowed to run freely. Instead it was pressed against the edge of the pulley. At the same time, the telephone pole forming the lower anchor yielded a little and kept swaying back and forth. This led to continuous small tugs on the taut rope while students were being lowered down. At the point of breakage, there were signs of melting 2-3mm into the rope, before the remaining fibres in the core had failed, partly cut off and partly torn. The rope had seemingly been grating against the sharpened edge of the pulley. Eventually this generated enough frictional heat for the edge of the pulley to melt through the sheath of the rope and into some of the core fibres. The rope snapped when the remaining fibres could no longer support the load. No one was injured. The pictures on this page show the cut rope and the pulley that was used.

This Tyrolean traverse was improperly rigged, and the rope was repeatedly subjected to adverse load from the pulley, which weakened the rope and eventually made it snap. A separate report has been prepared about this accident.

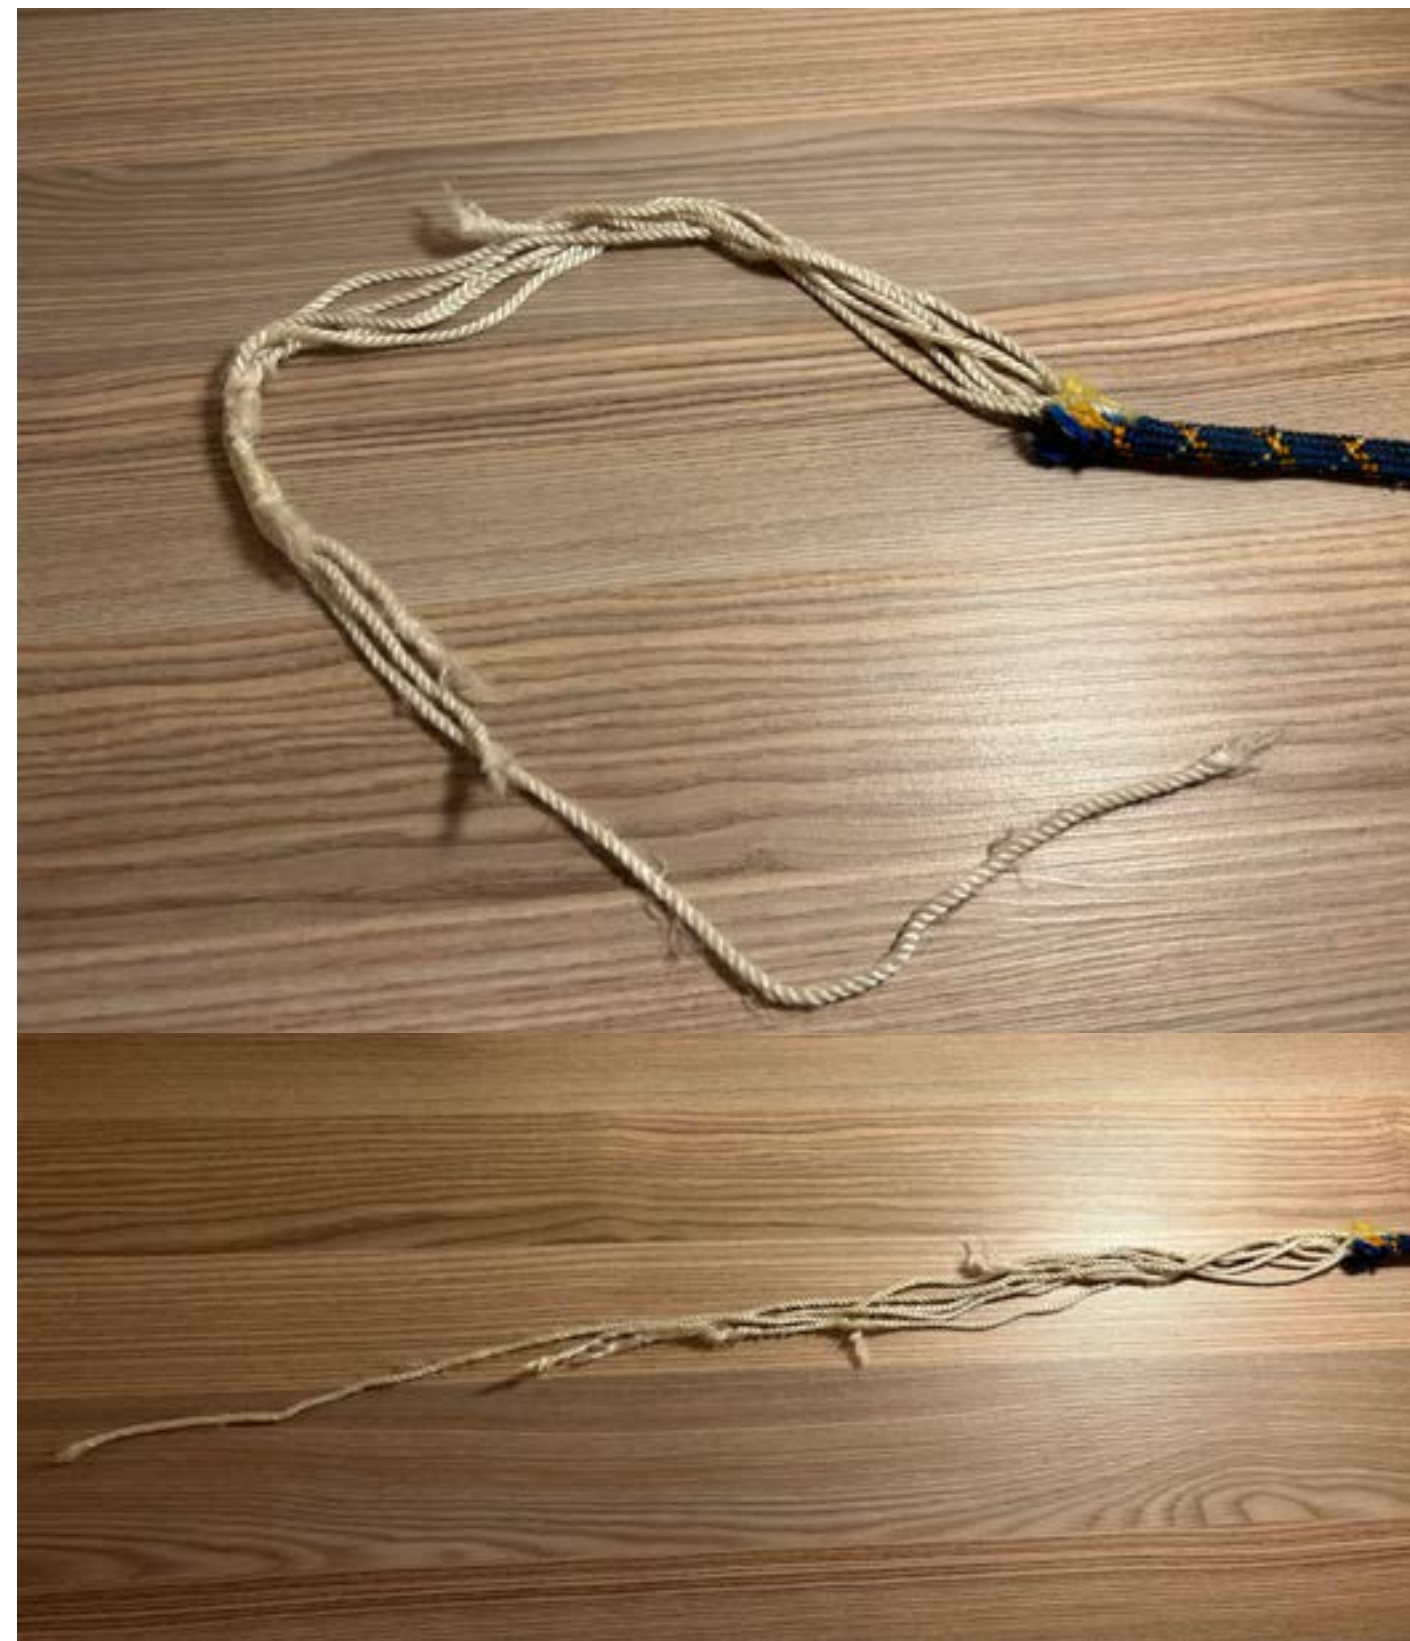
June 2003, Hornaksla, Romsdalen

A climber on the route *Philipshave* took a controlled fall on an apparently well placed camming device. The cam came out when it was loaded. One half rope, an almost brand new 8.5mm rope, was loaded against the edge under a small corner and was cut. Since only this rope was connected to the top three anchor points, the fall was extended to 15m. The climber tumbled, hit his head on the wall and had his forehead cut. The pictures below show the cut rope.

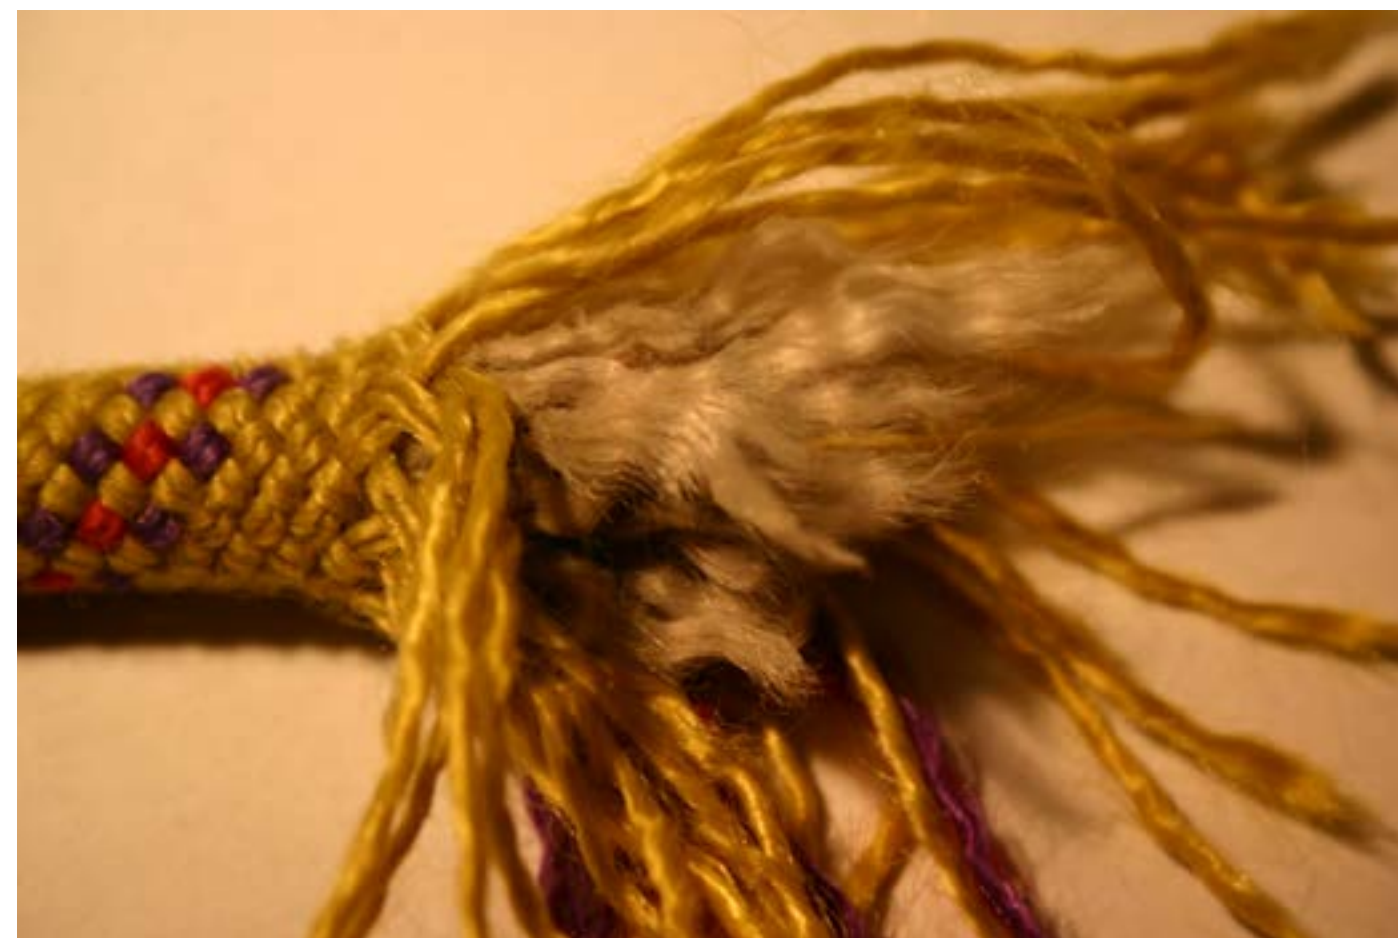
June 2005, Hardangerjøkulen

The picture below shows the cut rope at Hardangerjøkulen

An 11mm rope broke during a rescue exercise with a 1:3 hoist during a glacier instructor course. The rope was placed over a bag near the crevasse rim to prevent it from digging into the snow. The hauling was heavy, and two people were pulling at the top with all their might when the rope broke sharply. The point of failure was above the crevasse, between the bag and the person standing closest to the crevasse. The person hanging in the crevasse was caught by a separate safety rope and no one was injured. The rope was not in visible contact with any sharp objects where it broke. The bag was examined for sharp objects, but none was found. The cause of the rope break remains unknown. The rope's age, history of storage and history of usage could not be determined. There were no visible colour changes or colour variations on its surface around the point of failure. The broken section did not appear to have been cut, but looked more like it had been torn. The fibre length at the break varied with long fibres in the middle and short one towards the outer edge. There was no heat damage to the fibres. One hypothesis is that the rope had undetected prior damage, either mechanical or chemical. Another hypothesis is that there was a sharp edge on the bag at the rim, which was either not detected or not considered sharp enough to cause a rope cut when examined.

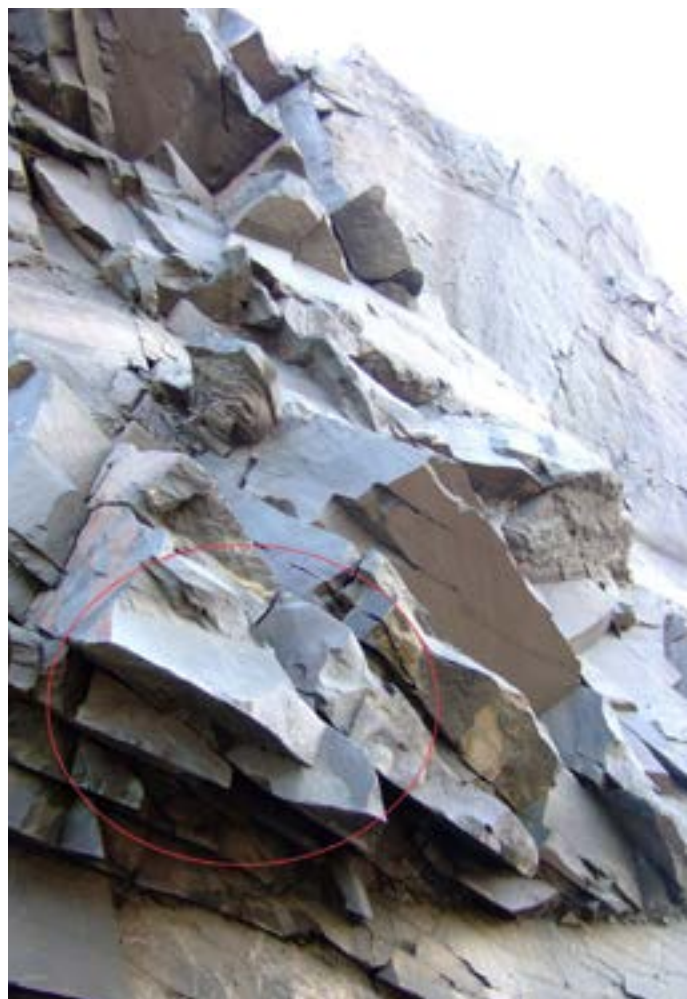
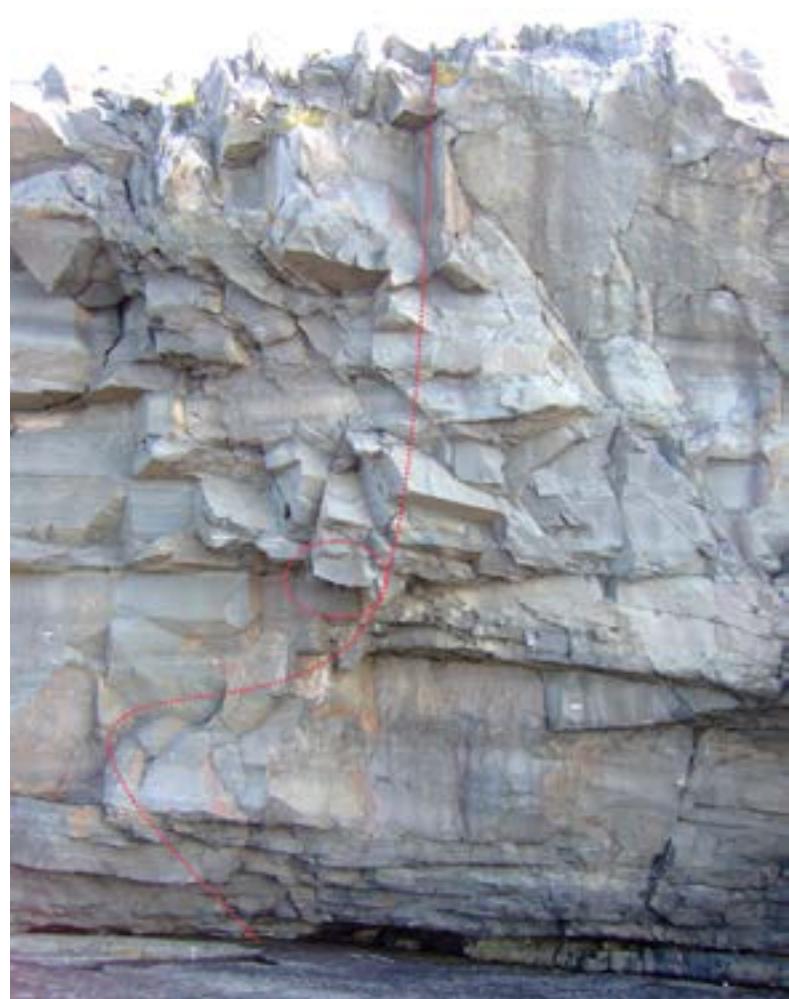
June 2008, Vardø

A climber on a top rope fell into pendulum swing after a controlled fall. As a consequence the rope was dragged across a sharp edge two or three times and then broke sharply. The climber was two metres above the ground and escaped with no injuries except for a sprained arm.

Lateral movement and cutting forces applied to a single point on the rope caused the cut. We do not have any pictures of the rope from this accident, but the pictures below show the crag, and the sharp edge is marked with a red ring.

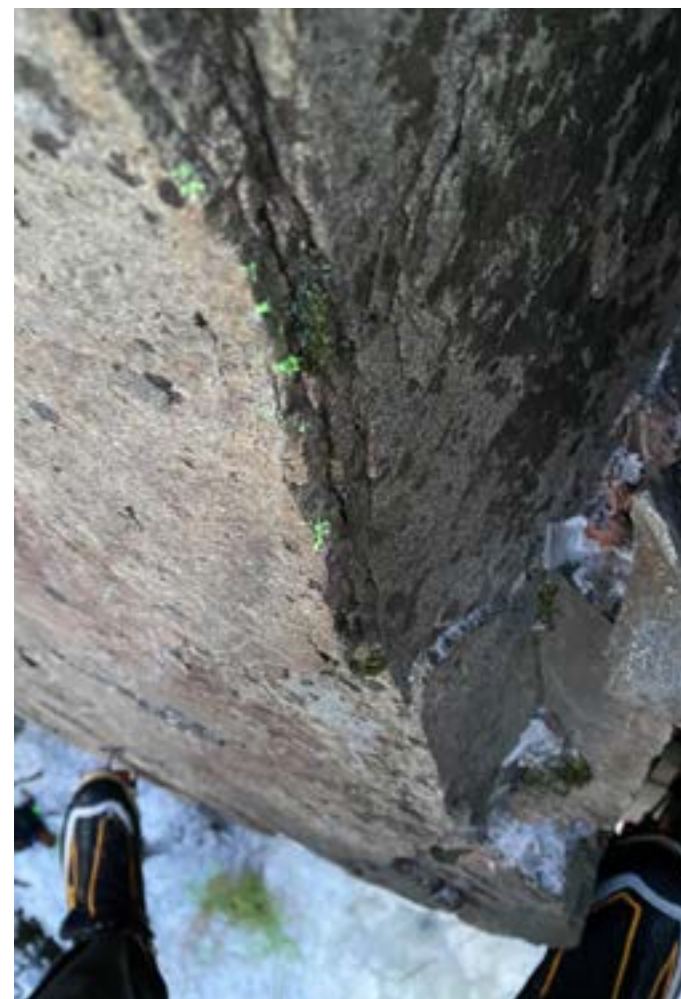
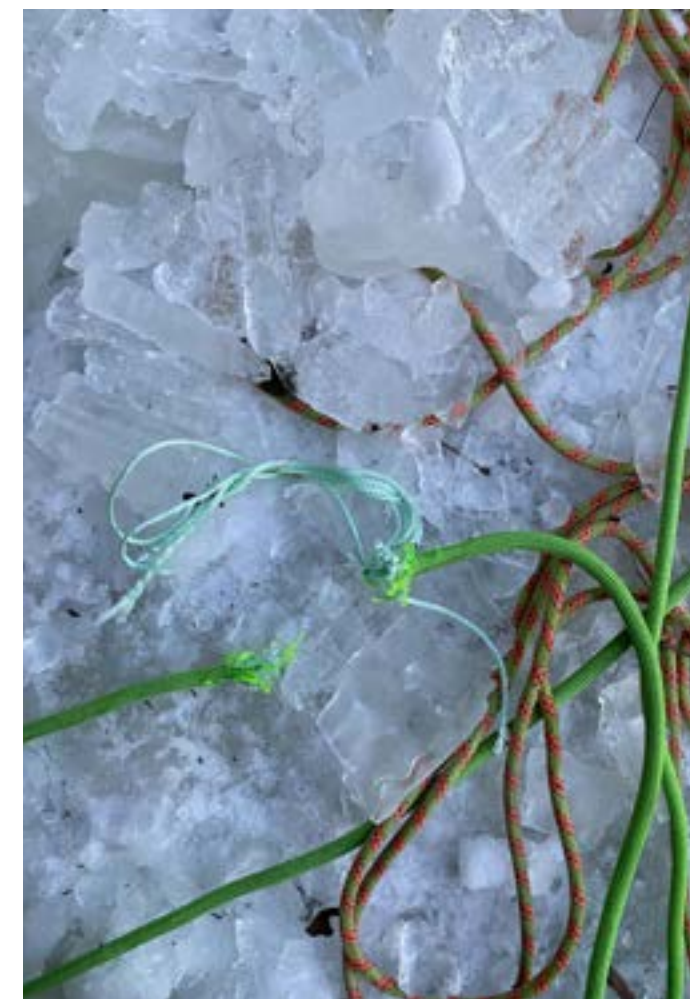
January 2021, Jaklefoss, Ringkollen

During drytooling with natural protection, one of the lead climber's half ropes was run over a sharp edge. When the climber fell one half rope was cut. The other half rope prevented a ground fall. The left picture shows the edge that cut the rope and remains of rope fibres (green). The right picture shows the cut rope.

In a video of the fall, we can see the rope moving along the sharp edge and breaking during this movement. The usage of half ropes prevented a more serious fall in this case.

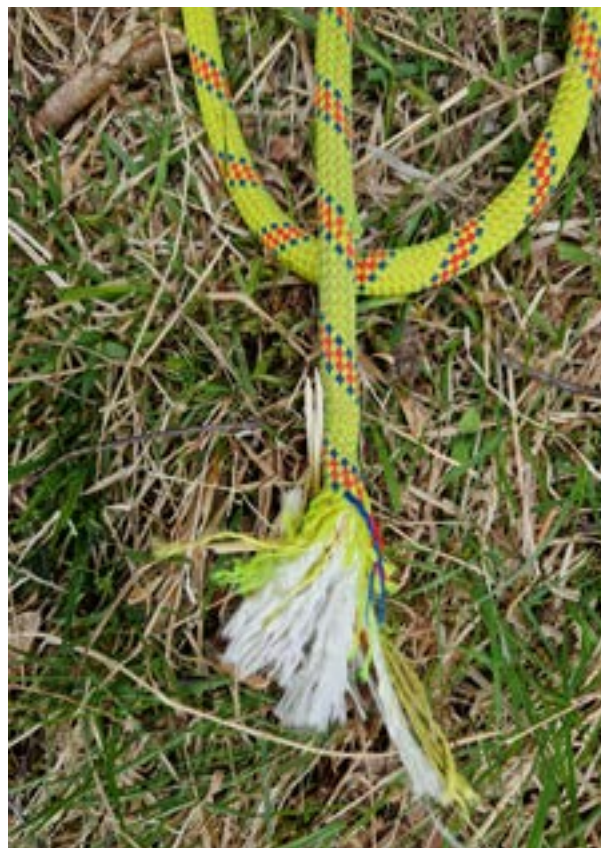
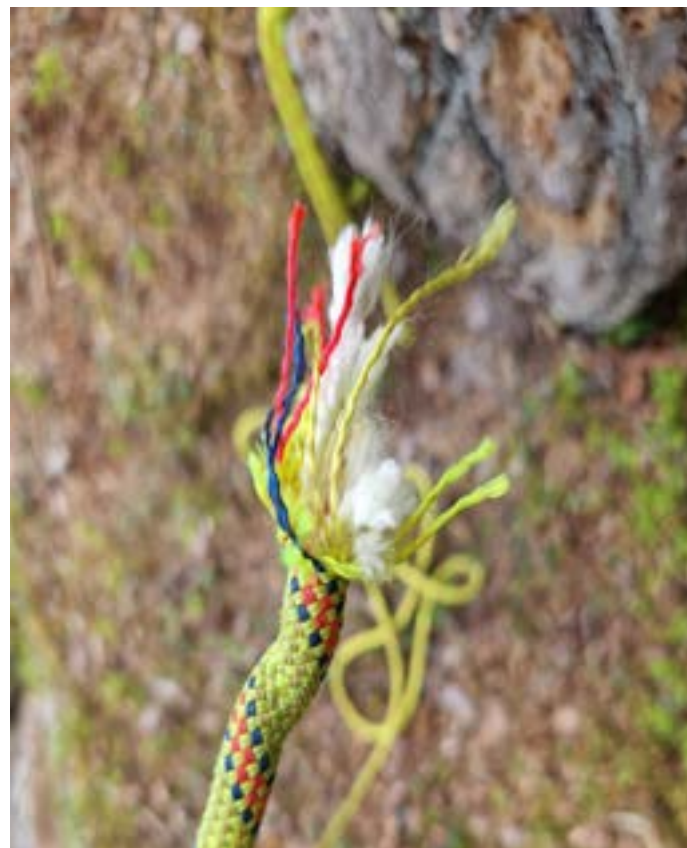
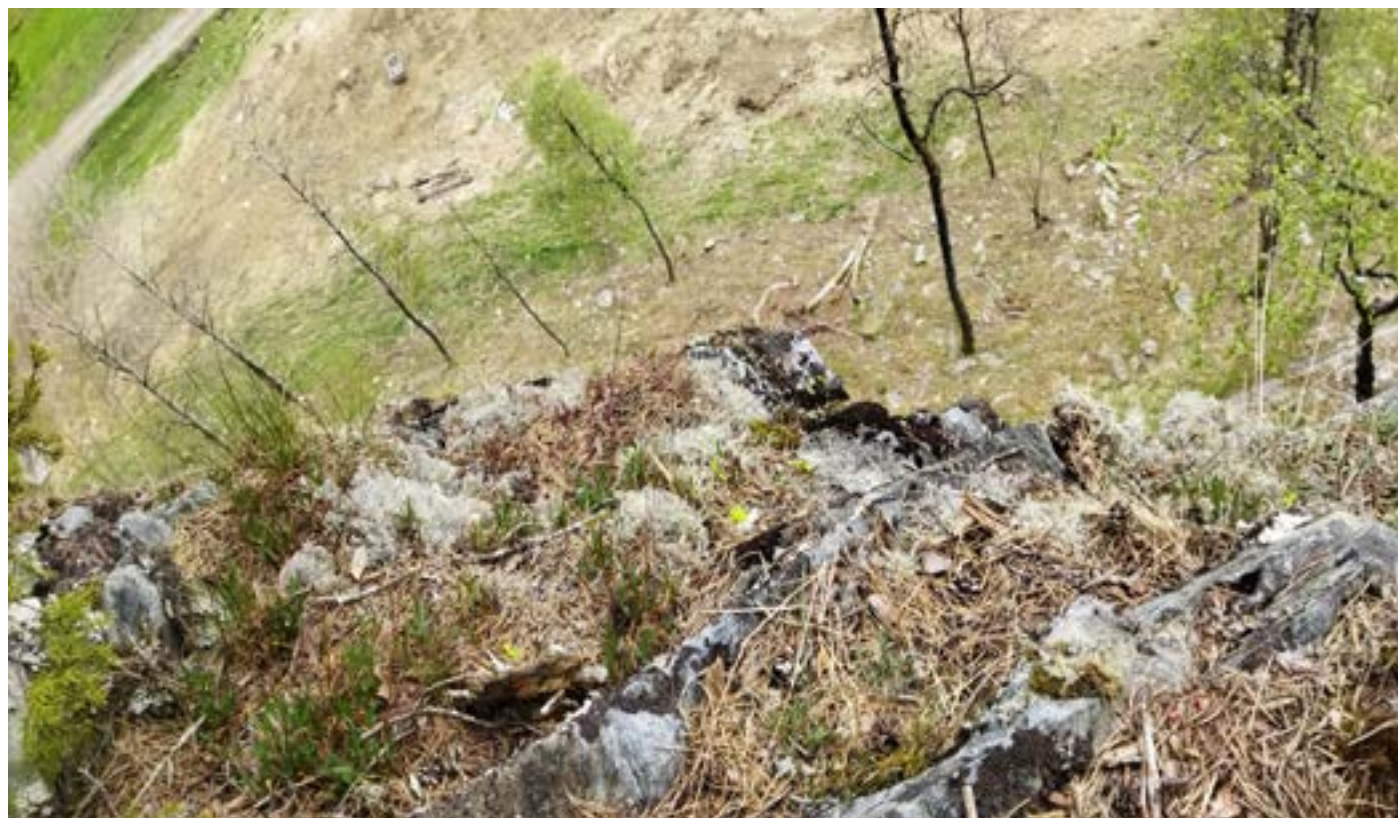
May 2023, Staup, Voss

During a supervised abseil, the rope breaks sharply as a teenage student jumps off and the rope hits the edge. The tight rope probably moved laterally over a sharp edge and was cut. She fell 12 metres and suffered a broken back, a dislocated collarbone, and a torn knee ligament.

Jumping over the edge creates a large force on the rope, and when the rope under tension slides sideways against a sharp edge, a clean cut is made. The pictures show the cut rope and some of the sharp edges at the scene (note the remains of rope fibres). A separate accident report has been written about this accident.

- Do not use fixed single ropes for supervised abseiling. Use two ropes or a rope laid double (which can often be fixed on top). This provides redundancy. If one rope breaks, there is a chance that the other one does not. The load is also halved, making the ropes much more resistant to sharp edges than a single rope would be.
- Examine the abseiling location, and avoid places where there are sharp edges.
- If abseiling on a fixed single rope (for route development, maintenance and instructor work), use a low stretch rope and put on rope protectors where the rope is in contact with the rock.
