REPORT OF TESTS CARRIED OUT ON ANCHORS IN THE MARINE ENVIRONMENT

Report Author: Francisco Manuel Martinez Huelva
Translation: A.R. Jarvis 2017-06-05

REPORT OF TESTS CONDUCTED ON ANCHORS IN MARINE ENVIRONMENT

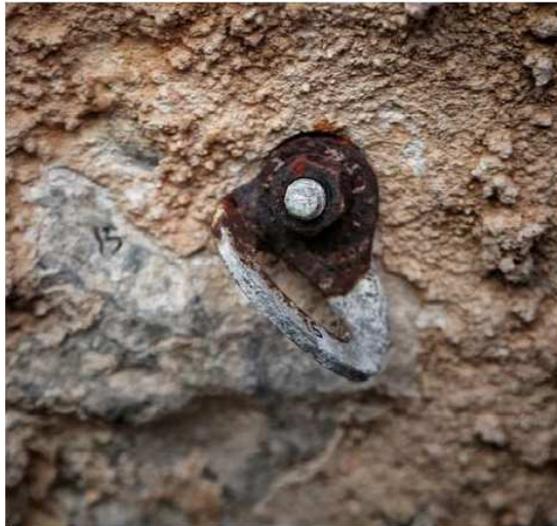
1. Flexotraccion test of number 15: carbon steel, resistance 18.5 kN, rupture failure by the plate.
2. Flexotraccion sample of number 41: carbon steel, resistance 10.5 kN, rupture failure by the plate.
3. Flexotraccion test of number 45: galvanic corrosion, resistance 17 kN, break failure by parabol.
4. Flexotraccion test of numeral 47: carbon steel, resistance 16 kN, breakage failure by parabol.

The zones of Mallorca between 1.5 and 7 km of the coast would fit the location Zones 2 and 3 as determined by the UIAA. **Therefore, it is recommended to use duplex or superaustenitic anchors with release of stresses.** It is possible to make use of other types of lower resistance materials, requiring an in depth study of the specific area to be installed.

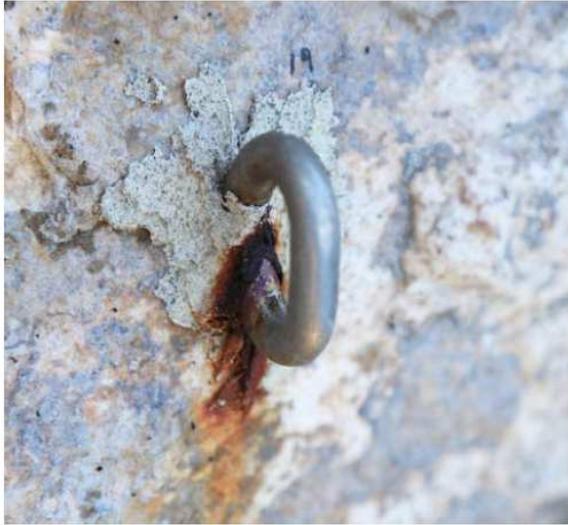
There is a notable loss of strength in the 304 stainless steel anchors and the dispersion values are considerable within even the same type of track. This is due to the stress corrosion that we have detected in the different analyzes under a microscope. The values obtained have been quite worrying. In principle, there is no imminent risk, since the tests have been carried out in climbs have been retrofitted, but the same type of material and anchor design has been used **must be replaced in a minimum period of 6 years.**

1. Axial test sample number 19: stainless steel 304, resistance 3 kN, breakage failure by welding.
2. Axial test of sample number 20: stainless steel 304, resistance 24.5 kN complete extraction.
3. Flexotracción test sample number 25: stainless 304, resistance 6 kN, break failure by the parabol.
4. Detail image of break of sample number 25.

The areas of Menorca situated on the coastline would fall between Zone Type 1 and Zone 2 designated by the UIAA. So it is **recommended to make use of Titanium anchors.** It would need a study of greater depth to determine if the use of materials such as Duplex (PLX) or Superaustenitic with stress release treatment, were suitable.

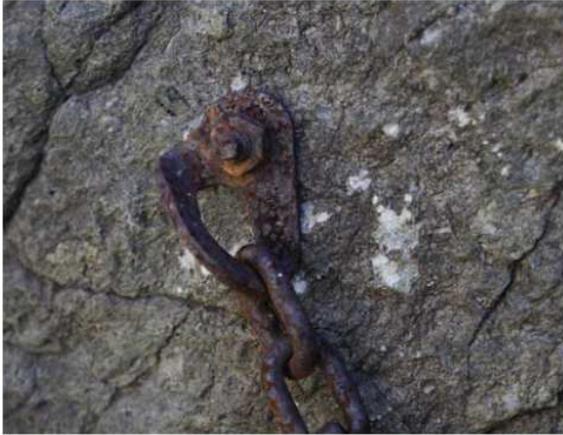
1. Flexotraccion test sample number 19: carbon steel, resistance 20 kN, break failure by parabol.
2. Detail image of breakage of sample number 19.
3. Flexotraccion test sample number 20: carbon steel, resistance 20.5 kN, rupture failure by the plate.
4. Flexotraccion test shows number 21: carbon steel, resistance 21 kN, rupture failure by the plate.

The zones of Las Palmas of Gran Canaria between 1.5 to 12 km of the coast would comprise, between Zone 2 and 3 as designated by the UIAA. So it is **recommended to use duplex (PLX) or superaustenitic anchors with stress release treatment**. It might be possible to use of other types of lower quality materials, but it needs an in-depth study of the specific area to be installed.

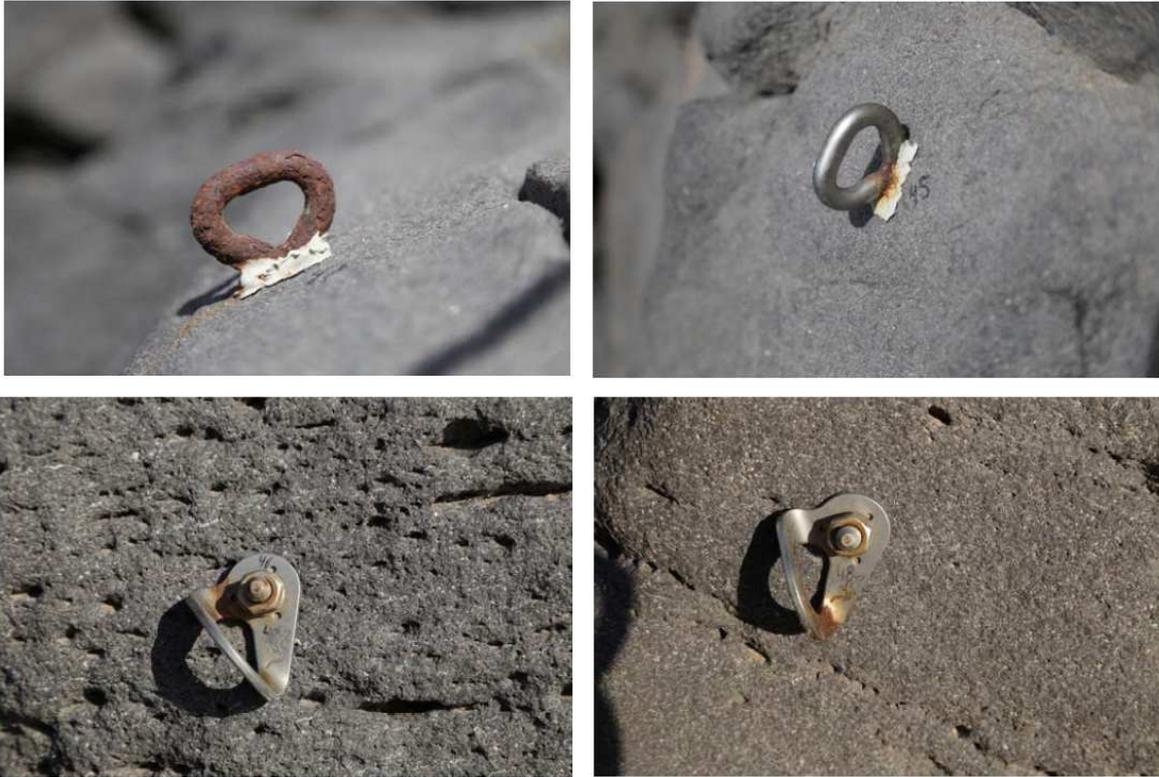
The behavior of carbon steel has performed much better than steel Stainless 304, due to the different forms of corrosion that affect them. In the different samples of steel Stainless steel 304 in which microscopic analysis has been performed, **stress corrosion cracking (SCC) has been detected**. This is a very worrying factor to which the local climbing community has been alerted.

1. Axial test, sample number 41 carbon steel, resistance 25 kN, complete extraction.
2. Axial test, sample number 45 aceroinox 304, resistance 10 k, breaking side opposite to welding.
3. Test flexotracción sample number 46 stainless 304, resistance 4 kN, breaking failure by the parabol.
4. Test flexotracción sample number 48 stainless 304, resistance 3.5 kN, breakage failure by the plate.

The areas of Lanzarote situated on the coastline would fall between Zone Type 1 and Zone 2 designated by the UIAA. So it is **recommended to make use of Titanium anchors**. The use of materials such as Duplex (PLX) or Superaustenitic with stress release treatment, would need a study in greater depth of the area to be carried out. Although the information we have is scarce, **we do not know how sulfur chlorides contained in basaltic rocks can react with Titanium**.

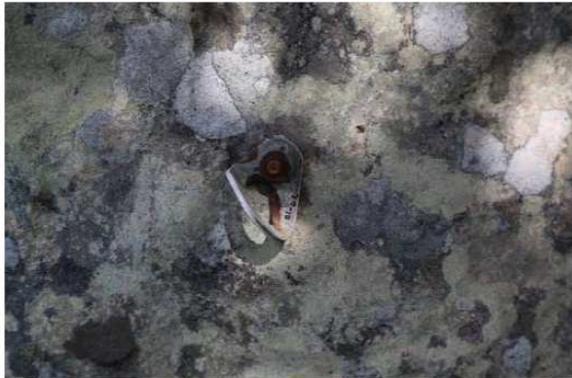
1. Flexotraction test shows number 2 carbon steel, resistance 19, breaking failure by parabol.
2. Flexotraction test shows number 5 carbon steel, resistance 20 kN, breaking failure by parabol.
3. Flexotraction test shows carbon number 7, resistance 22 kN.
4. Flexotraction test shows number 12 carbon steel, resistance 22 kN.

The areas of Bolonia situated 7 km from the sea would fall within the type of Zone 3 as called the UIAA. So it is **recommended to use 316 L stainless steel anchors.**
