Sharp edges and rope cuts

This document is an English language translation of the original 'Skarpe kanter og taukutt', produced in Norwegian by the Norges klatreforbund (NKF)/Norwegian Climbing Federation (NCF), a UIAA full member. The document is produced in collaboration between the safety commissions of the NKF/NCF and the UIAA.

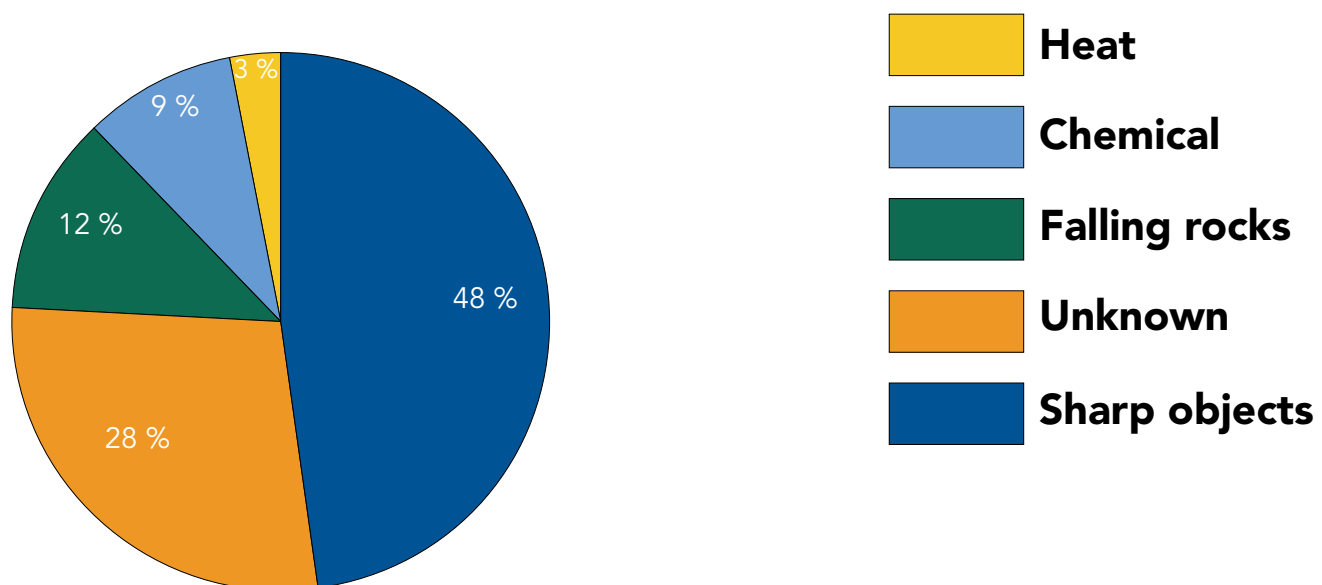
Causes of rope breaking

Fortunately, climbing ropes rarely break. However, it has happened often enough that we can form a picture of the different mechanisms that can lead to a rope break. In the 1960s, the safety pioneer Pit Schubert from the Deutscher Alpenverein (DAV)/UIAA Safety Commission started collecting data on rope breaks and their causes. Between 1969 and 2018 (50 years), the DAV collected information on a total of 53 cases. Adding data from the American Alpine Journal and other sources, there are 128 cases of known rope breaks in this period, i.e. just over two rope breaks per year on average. The accident causes are distributed as shown in the figure below. In 28% of the cases there is not enough information or data to determine the cause. The dominant

cause is cutting against sharp objects (48%). This can be sharp edges on the rock face, carabiners that are so worn down that sharp edges have formed in the metal, or more exotic causes such as the rope being cut by an ice screw crank that was not tilted up after placement. Rockfalls account for 12% of the incidents, and contact with chemicals 9%. Acids, especially battery acid, are very harmful to the rope and such damage can be difficult to see. On the other hand, gasoline, Coca Cola, urine, seawater and UV radiation have little effect on ropes, according to tests carried out by Pit Schubert. After 1982, Germany saw a noticeable decrease in fatal rope breaks as a result of the majority of alpine climbers switching to double ropes, which provided redundancy in the belay system.

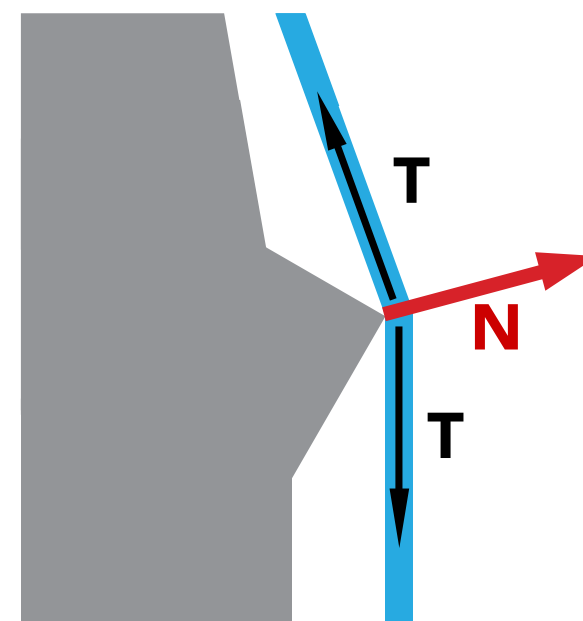
Cutting force: When the rope rests against a sharp edge, the edge will assert a normal force (N) perpendicular to the rope. The other force at this point is the tension (cord tension) of the rope (T). For those who listened closely during their physics classes at school, it is obvious that the greater the tension of the rope, the greater the normal force from the sharp edge on the rope will be. See the figure below.

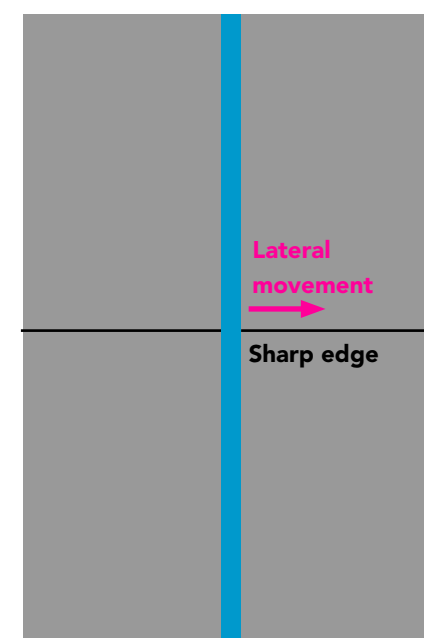
If the same point on the rope now moves laterally along the sharp edge, the normal forces will make the rock cut into the rope in the same way as when cutting it with a knife.

How much lateral movement it will take to fully cut the rope in this way will depend on the rope load. Greater load gives greater rope drag which in turn gives greater normal force and thus a shorter sliding distance before the rope is completely cut. Experiments done at Edelrid's laboratory show that increasing the rope load from 80kg to 160kg reduces the sliding distance before a cut happens to 1/4. Increasing the rope diameter appears to have some effect on the sliding distance before cutting occurs, but the diameter of the rope matters much less than the rope load.

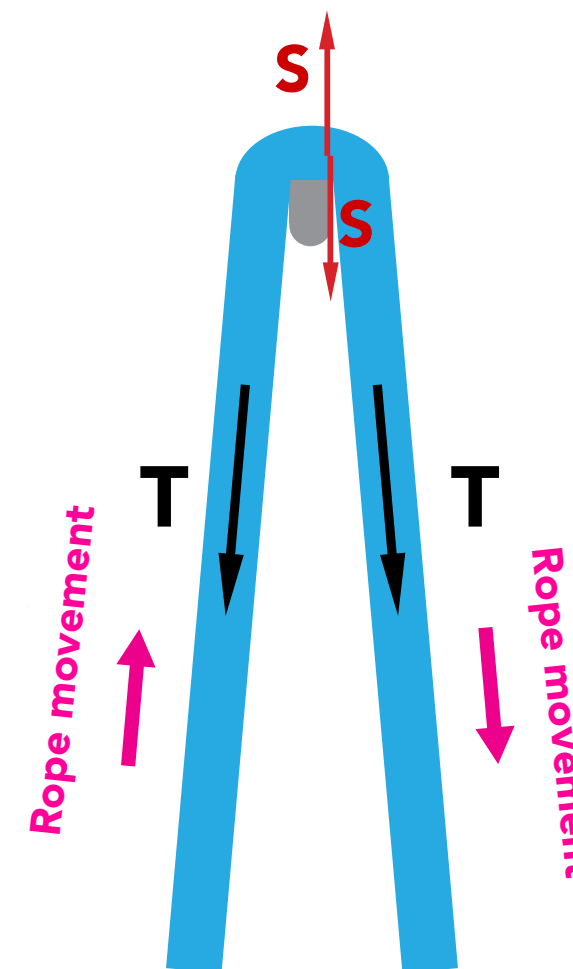
Shear forces: These are internal forces in the rope that act perpendicularly to the length of the rope. In any cross section of the rope, the part of the rope to one side of the cross-section will be subject to shear forces from the part to the other side of the cross section. Again, if you paid close attention during your physics classes at school, you know that Newton said that such forces are equal in magnitude and opposite in direction, and that they act on every part of the rope. A pair of shear forces (S) are shown in the figure where a loaded rope is bent over a carabiner, as happens if you fall or if you are lowered from an anchor.

Shear forces commonly occur in the belay system, but they become very dangerous if there are sharp edges on the metal that the rope slides over. Especially carabiners that have been in place on a route for a long time will wear from repeated lower-offs. Deep grooves can form in the carabiner material, and sharp edges can be found in these grooves. Such grooves often form in carabiners on the first and second bolt on the route, or under overhangs where the rope changes direction. Such edges do not necessarily feel sharp when touched with a finger, but they could be more than sharp enough to damage a rope that is forcefully loaded over the edge. In the worst case, it is cut completely. The carabiner pictured below belonged to a permanently placed sling that was taken down from the route Aloha on the crag *Beachen* in 2022. The risk of rope damage or rope cuts on this carabiner is very real.
